TIRE INFORMATION SERVICE BULLETIN

INSPECTION PROCEDURES TO IDENTIFY POTENTIAL SIDEWALL “ZIPPER RUPTURES” IN STEEL CORD RADIAL TRUCK/BUS AND LIGHT TRUCK TIRES

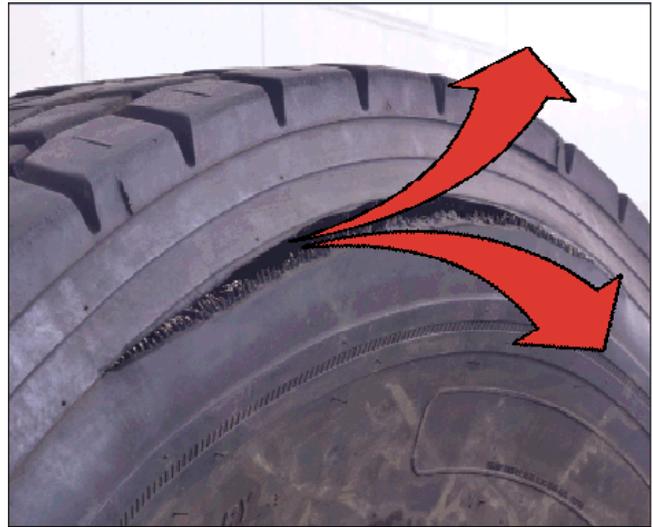
The photo in Figure 1 is an example of a zipper rupture in a truck tire casing. Note the characteristic “zipper-like” seam running along the sidewall where the rupture occurred.

FIGURE 1: Zipper Rupture Example

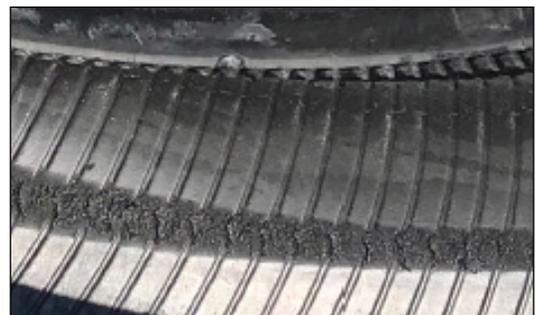
FIGURE 3: Note the abraded area on the tire innerliner. This condition is the result of the tire being operated under inflated and/or overloaded.

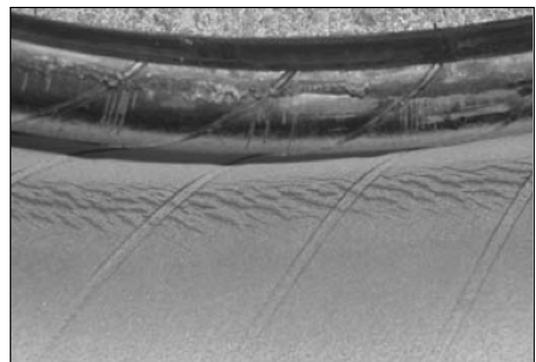
FIGURE 4: Wrinkled and discolored innerliner in the tire’s flex area is another sign of being operated under inflated and/or overloaded.

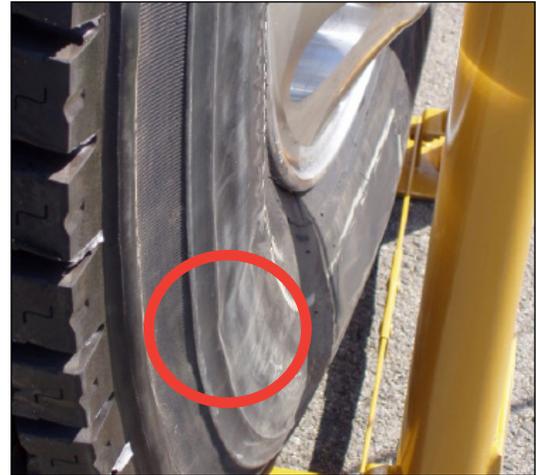
FIGURE 7: At 20 psi, you can begin to see the presence of distortions in the sidewall of this truck tire (circled in red). Due to a heavier sidewall construction, bus and refuse tires would present this condition at 40 psi.

If any of these conditions are present during inflation – stop! Do not approach the tire. Before removing from the restraining device, completely deflate the tire remotely. Remove the clip-on air chuck. The tire must be marked appropriately, made unserviceable and non-repairable, and then scrapped! If none of these conditions are present, with the valve core still removed, continue to Step 3.

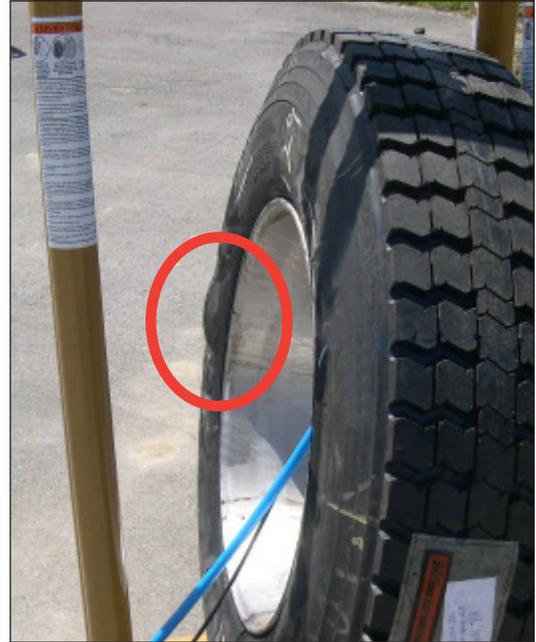
Figures 8 and 9 show a tire being inflated in a restraining device. The distorted sidewall indicates a potential “zipper rupture.”

FIGURE 8: Visible sidewall condition indicative of a pending “zipper rupture.” Note the bulge in the sidewall.

If any of these conditions are present during inflation – stop! Do not approach the tire. Before removing from the restraining device, completely deflate the tire remotely. Remove the clip-on air chuck. The tire must be marked appropriately, made unserviceable and non-repairable, and then scrapped! If none of these conditions are present, remove the clip-on air chuck, install the valve core, and adjust the inflation pressure to the recommended operating inflation pressure.

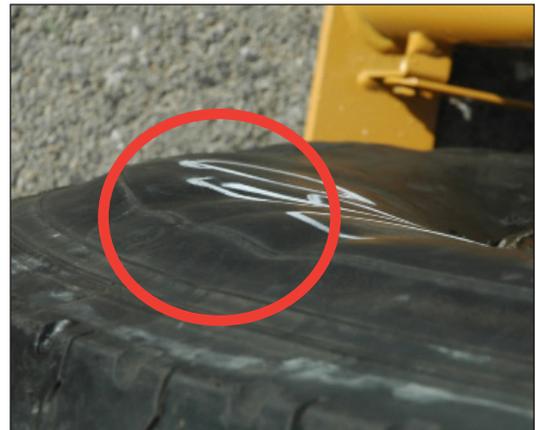
FIGURE 9: Visible sidewall condition indicative of a pending “zipper rupture.” Note the undulating rippled sidewall.
