TIRE INFORMATION SERVICE BULLETIN

INSPECTION PROCEDURES TO IDENTIFY POTENTIAL SIDEWALL “ZIPPER RUPTURES” IN STEEL CORD RADIAL TRUCK/BUS AND LIGHT TRUCK TIRES

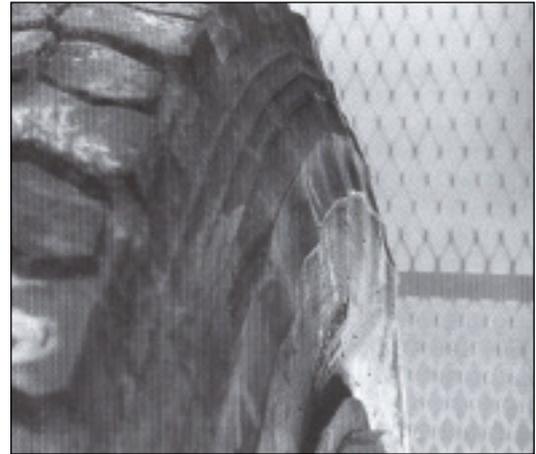
FIGURE 2: Using a grazing light or other indirect light source will produce shadows which indicate sidewall irregularities and/or signs of a possible “zipper rupture.”

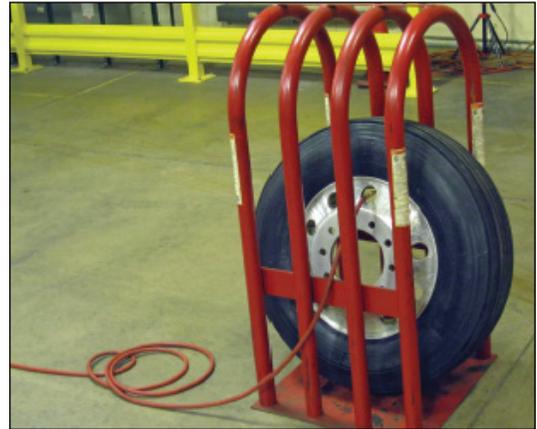
FIGURE 5: This is just one type of restraining device available for tire service facilities. With the valve core removed, inflate tire using a clip-on air chuck with a pressure regulator and an extension air hose.

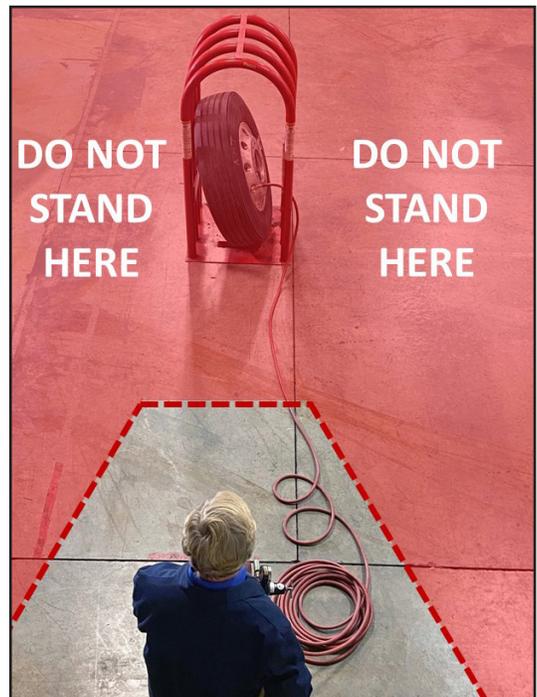
FIGURE 6: Proper inflation in a safety cage
